ROOF HAIL DAMAGE ASSESSMENT

Project: Brant Medical Clinic
6801 NW 39th Expressway
Bethany, OK 73008

Date of Loss: 5/16/10
File # 214.443

Date of Site Visit: 9/11/12
Time of Visit: 9:30 a.m.

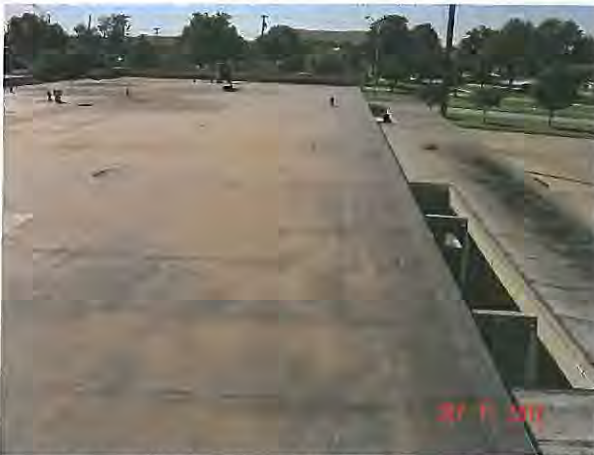
Roof Level 1:

The highest roof level which typically covers the lobby area has a smooth surfaced, heat fused modified bitumen cap sheet which exhibits a considerable amount of exposed fiberglass due to age and deterioration and lack of protective coating. The roof appears to have been installed in a singly ply fashion. Multiple repair attempts have been made on the roof. The roof has a raised perimeter edge, one internal roof drain and one small overflow scupper. The roof appears to be configured at a dead level slope and evidence of ponding water exists throughout the assembly. There

are two small aluminum vent caps constructed of very light gauge aluminum that exhibit small hail dings consistent with possibly pea or dime sized hail strikes.

Dirt has accumulated in the ponded areas and remains deposited on the roof surface. There are also small (pea to dime sized) visible splatter marks in the dirt that has accumulated on the surface of the roof where possible hail strikes have dislodged the dirt exposing the membrane below. I made a hands and knees examination of these splatter marks and find no evidence whatsoever of any hail damage to the roofing membrane.

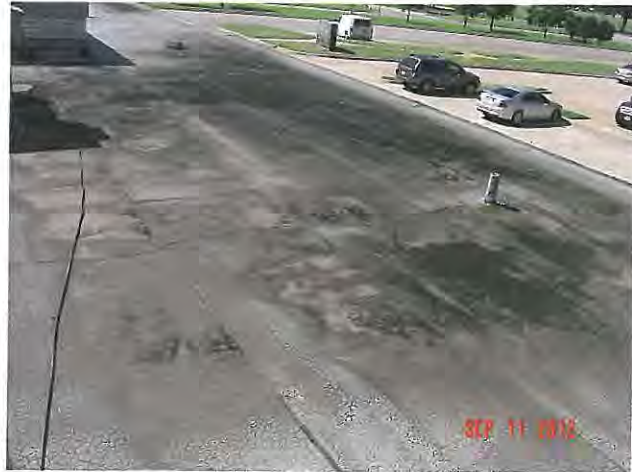
Roof Level 2:

The next lower roof level surrounds the high roof on at least three sides. This roof is a white granular surfaced mopped applied modified bitumen membrane that appears to be typically configured at a dead level slope. The roof edges are slightly raised and there is evidence of excessive ponding water throughout the roofing assembly. The roof exhibits blisters throughout the assembly, mud cracking in the surface and substantial granular loss; all due to age and deterioration and possible installation errors. There are multiple penetrations that are poorly detailed and many leak potentials exist at these penetrations and at blisters and loose laps. There are seven heater vents that are constructed of very light gauge aluminum that exhibit small hail dings consistent with possibly pea or dime sized hail strikes.

The granular loss and mud cracking typically occurs at the blistered and ponding areas making these defects obvious products of heat aging and deterioration. There is absolutely no pattern of granular loss on the roof that would be consistent with hail strikes. I carefully examined the areas where the granular loss has occurred for any hail damage to the roofing membrane and found none. Granular loss is a function of age and deterioration and in this instance is not the result of any hail storm. The most severe granular loss in this entire roof area occurs at the areas of the most severe ponding water.

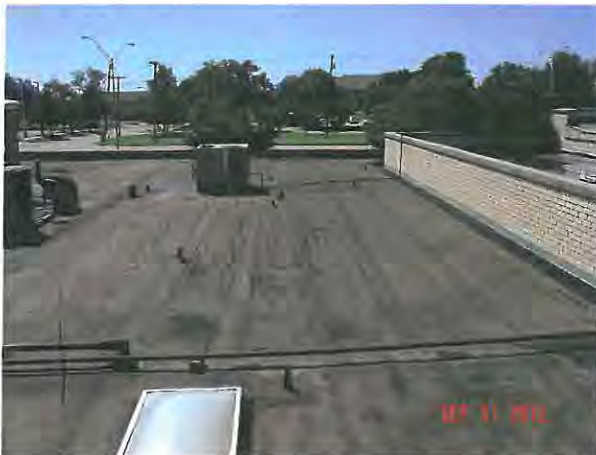
Roof Level 3:

The next lower roof level is a heat fused smooth surfaced modified bitumen membrane that appears to have been configured in a single ply fashion. This roof also is configured at a slope that is nearly dead level and ponds a considerable amount of water over most of the roof area. This is evidenced by dirt accumulation throughout the roofing assembly. Multiple leak potentials exist at improper penetrations, loose laps and drain detailing. Multiple repair attempts have been made.

There are two domed vent fan covers that are fabricated of light gauge aluminum that exhibit small hail dings consistent with possibly pea or dime sized hail strikes.

Dirt accumulation and vegetation appears at much of the roof. Very small surface mud cracking exists at much of the roof area due to age and deterioration. The dirt that has accumulated on much of the roof surface due to excessive ponding water exhibits splatter marks where small (pea to dime sized) hail strikes have dislodged the dirt on the surface of the roof. I made a hand and knees inspection at many of these splatter marks in the dirt surfacing on the roof and find no evidence of any hail damage to the roofing membrane. Blisters and wrinkles exist in the surface of the roof predominately at the areas that pond the most excessive water.

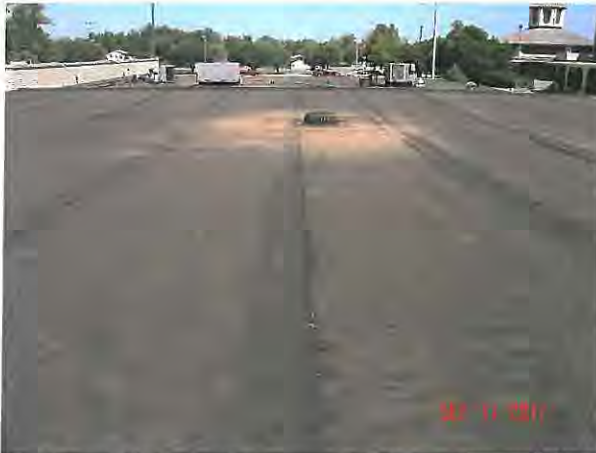
Roof Level 4:

This is a raised portion of the roof located near the southeast corner of the building. This area drains to one internal roof drain and appears to have slight slope to drainage except for an area of approximately $\frac{1}{2}$ square around the roof drain. This roof membrane appears to be the same age, general condition and type of construction as the roof noted above on area 3.

Dirt accumulation appears at some of the roof. Very small surface mud cracking exists at much of the roof area due to age and deterioration. The dirt that has accumulated on the roof surface due to ponding water exhibits splatter marks where small (pea to dime sized) hail strikes have dislodged the dirt on the surface of the roof. I made a hand and knees inspection at many of these splatter marks in the dirt surfacing on the roof and find no evidence of any hail damage to the roofing membrane.

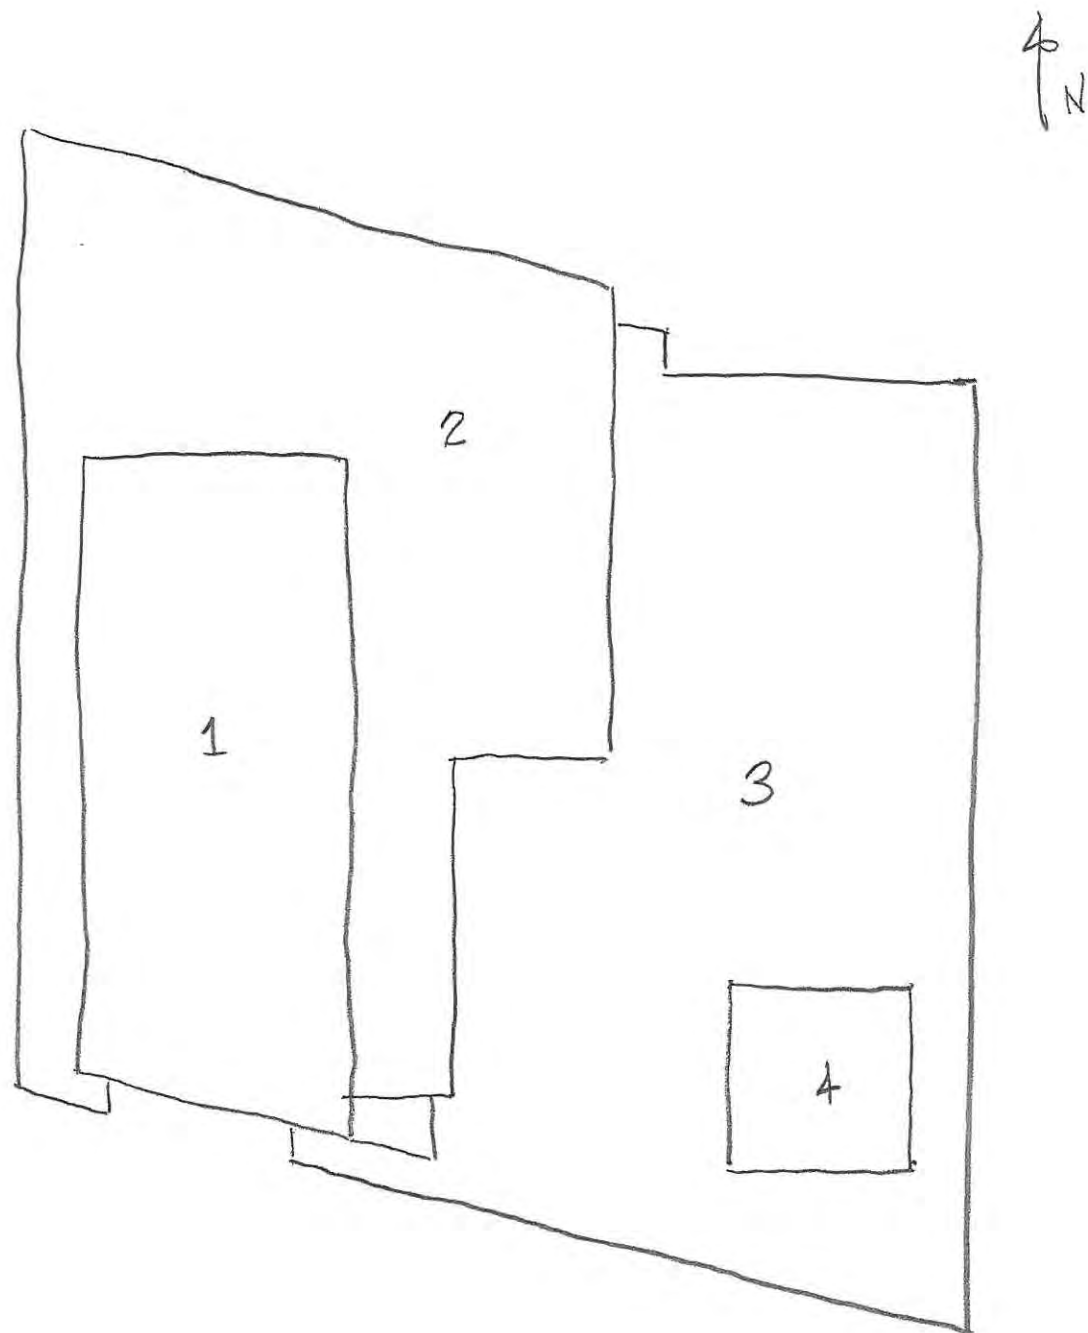
ROOF SKETCH
BRANT PROPERTY

The roof consists of at least three types of roofing materials configured at four different roof levels as shown on the attached roof sketch.

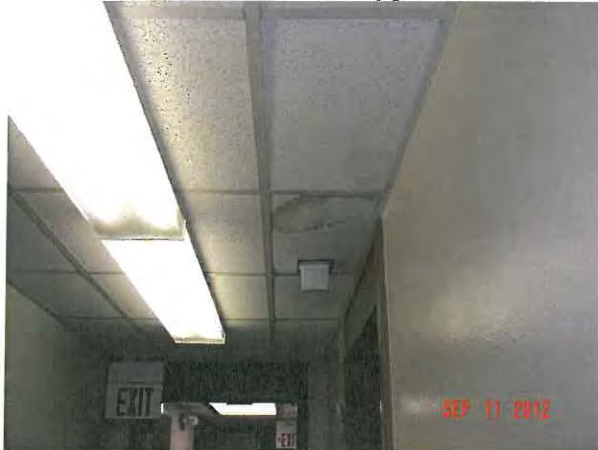
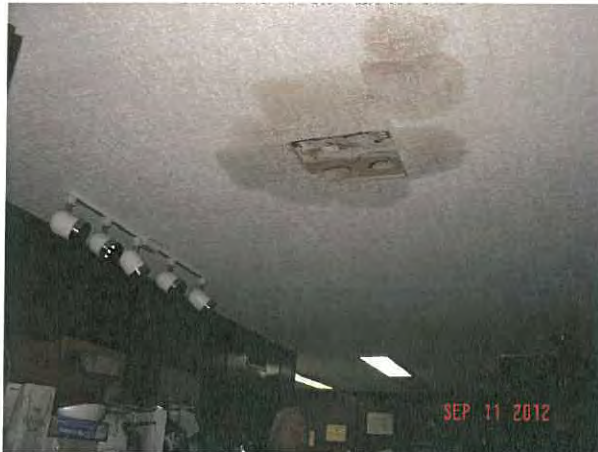
Typical interior leaks reported by Dr. Brant

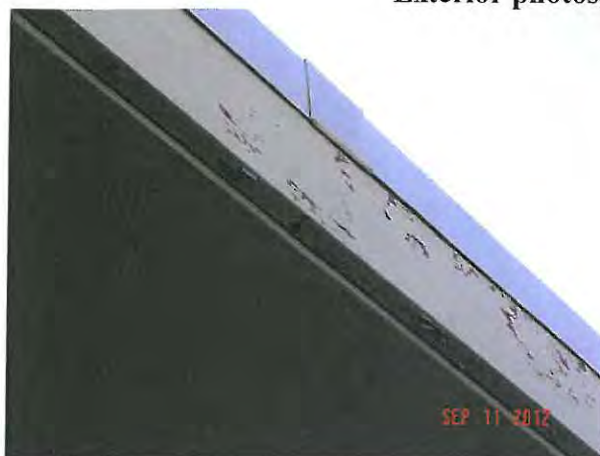
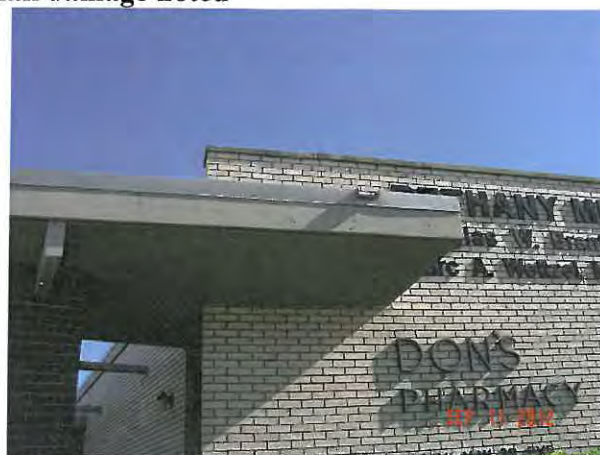
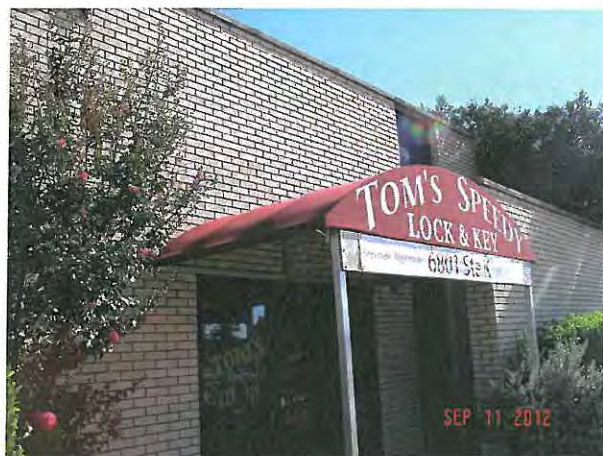
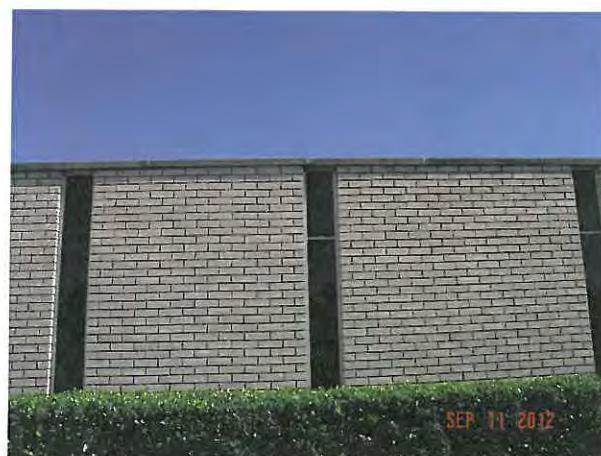
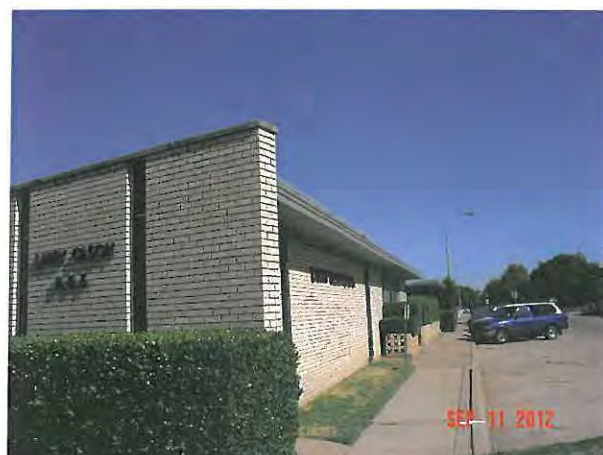
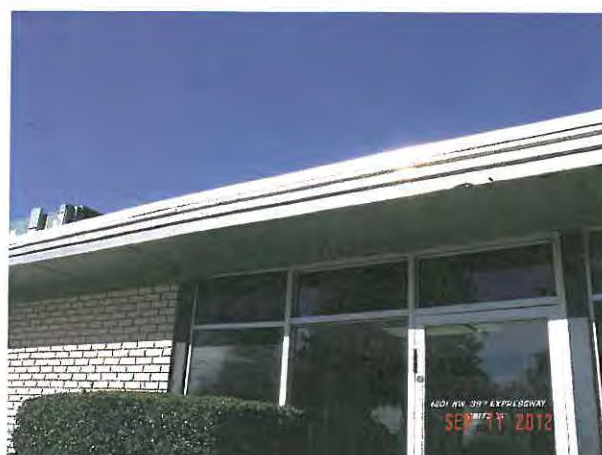
We then walked the perimeter of the building observing the building cladding systems and fascia, most of which is wood, some of which is aluminum. None of the wood or aluminum fascia system and wall cladding materials exhibit any evidence of hail damage.

Exterior photos, no hail damage noted

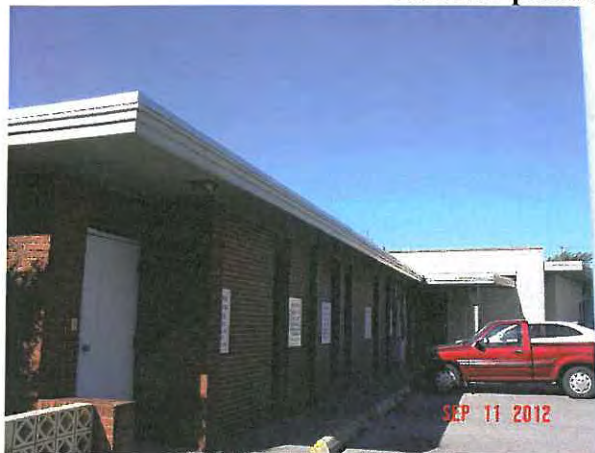
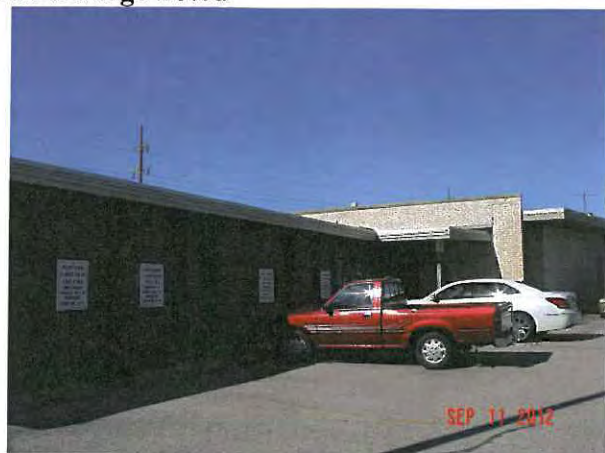
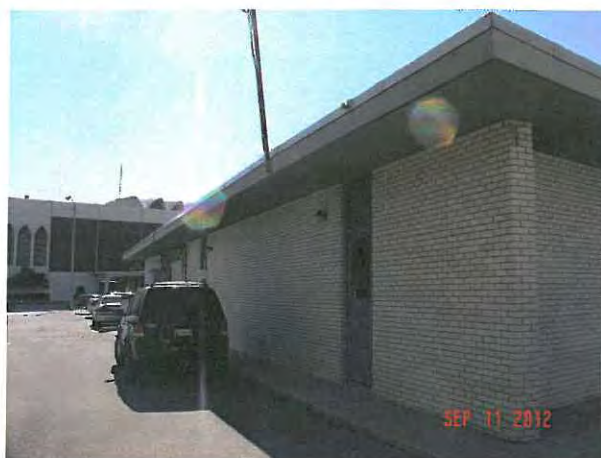
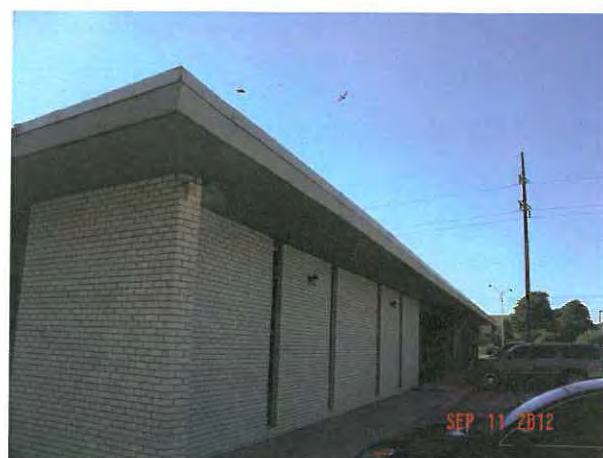
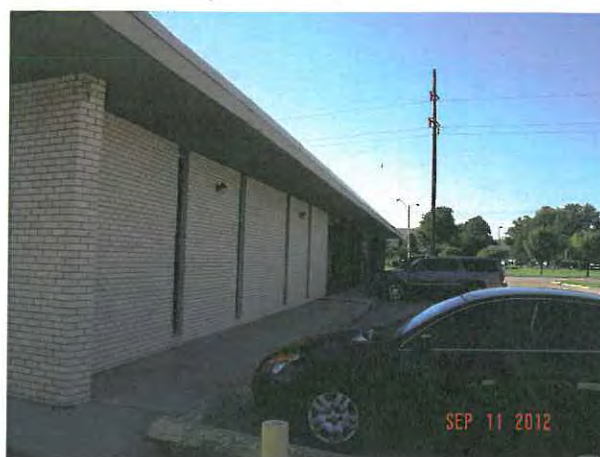
Exterior photos, no hail damage noted

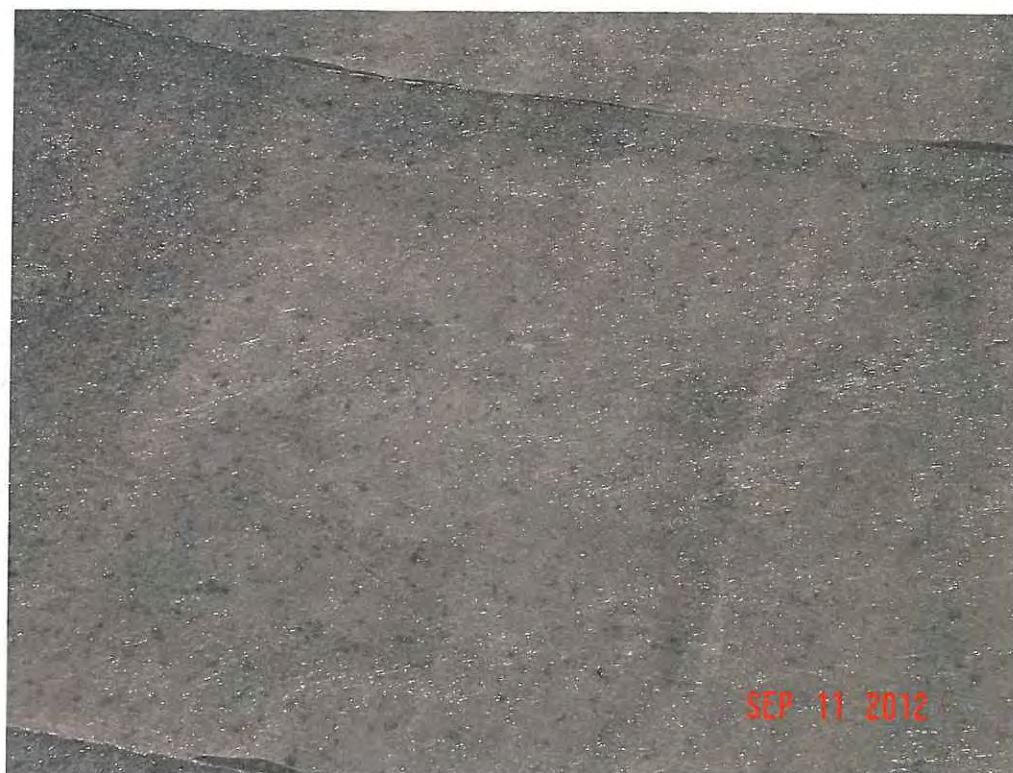
Small hail dings in soft aluminum caps

There is no hail damage to any of the membrane roofing assemblies on the subject building. Small hail dings on the aluminum vent caps are esthetic only and do not effect the performance of the caps. The caps can be replaced at a cost in the range of \$25-75/each. Damages to the coil fins of the roof mounted condensing units caused by the subject hail storm are minor and can be corrected by combing the fins.

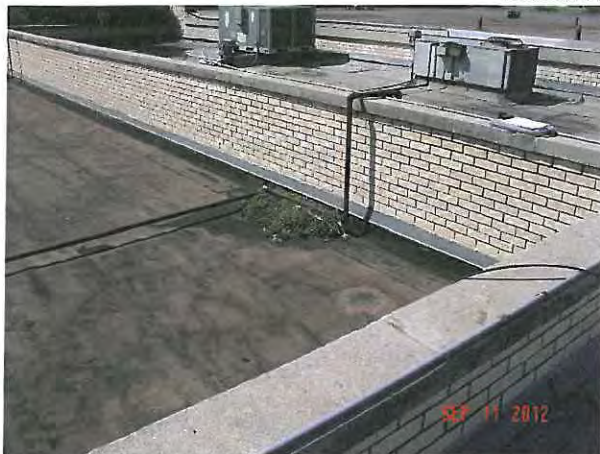
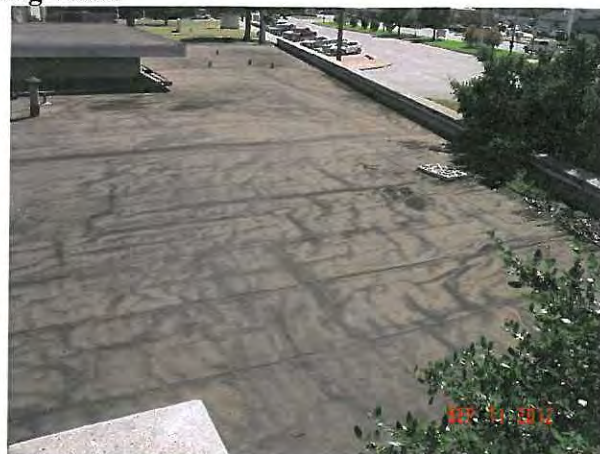
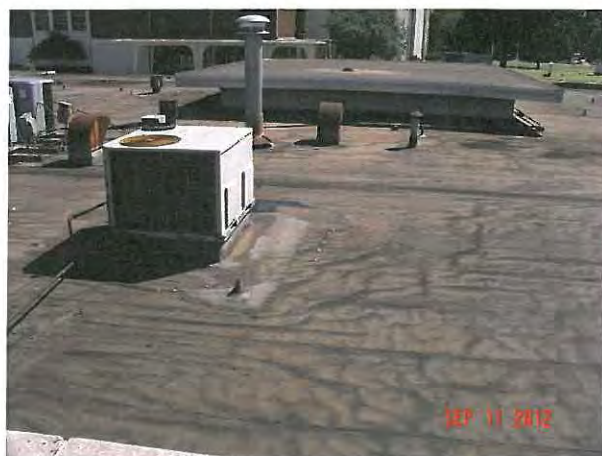
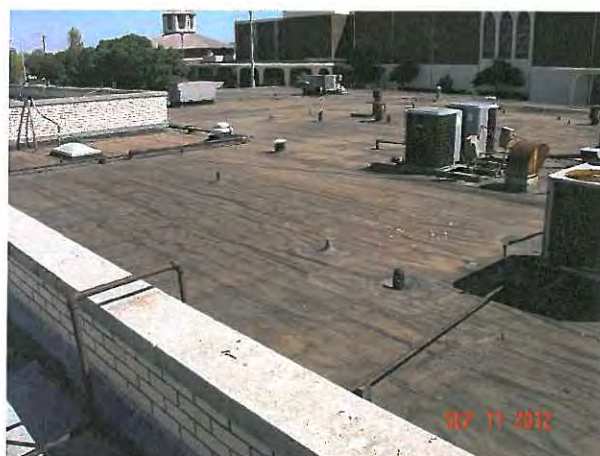
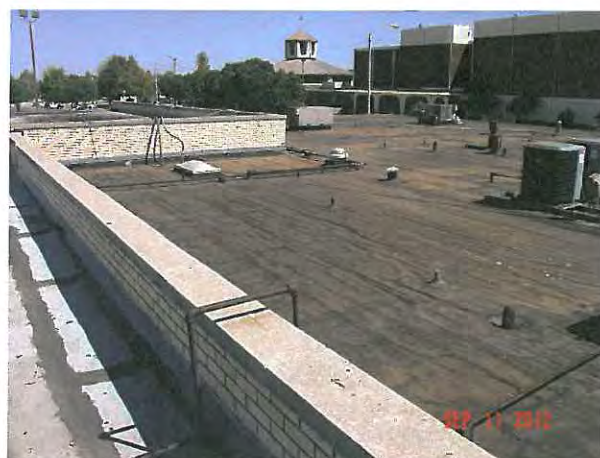
ROOF AREA 3

General roofing views

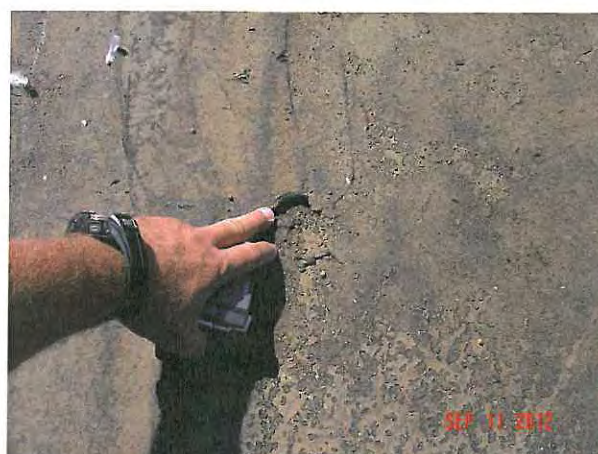
Improper repair creates leak potential

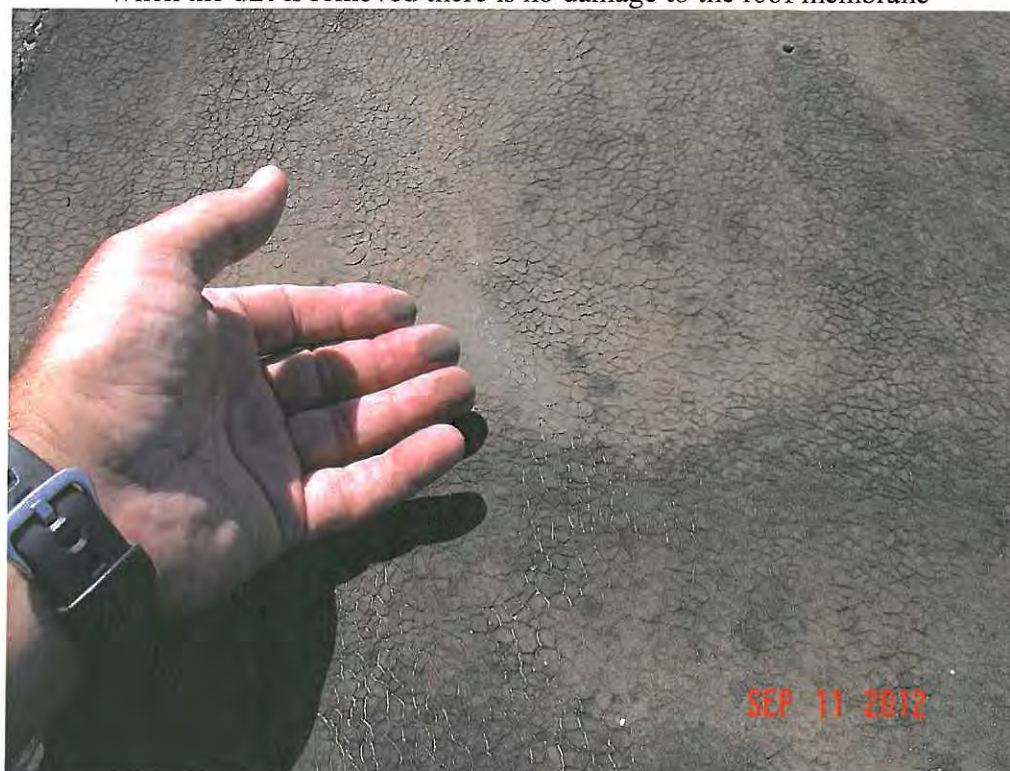
The splatter marks are displaced dirt only
When the dirt is removed there is no damage to the roof membrane
